## What Is Link Ejection in Rubber Tracks?

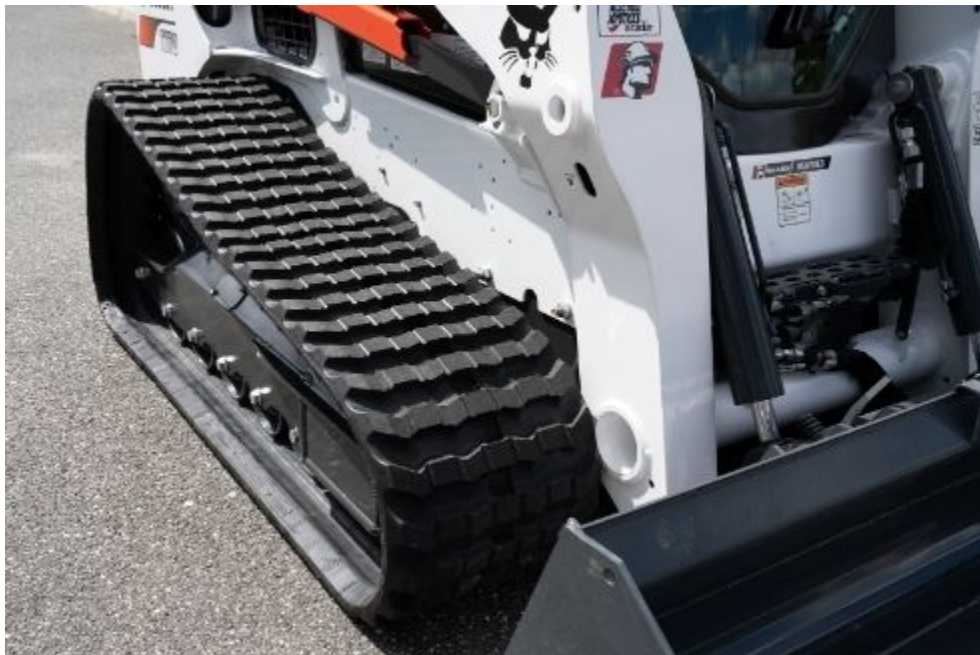
Link ejection in rubber tracks refers to when the forging or pin that serves as the bond between the rubber and the metal in the track breaks or gets ripped out. When this occurs, the track can't be repaired. Instead, operators will have to purchase an entirely new rubber track for their machine. To prevent downtime and added equipment costs, it is important to take measures to prevent link ejection from occurring. Essentially, there are five main types of link ejection that can occur. To learn about the different causes of link ejection in rubber tracks, continue reading.
